## FOREIGN BODIES: WHERE DID YOU COME FROM? EXPECTED AND UNEXPECTED FINDINGS IN THE **ABDOMINAL CAVITY**

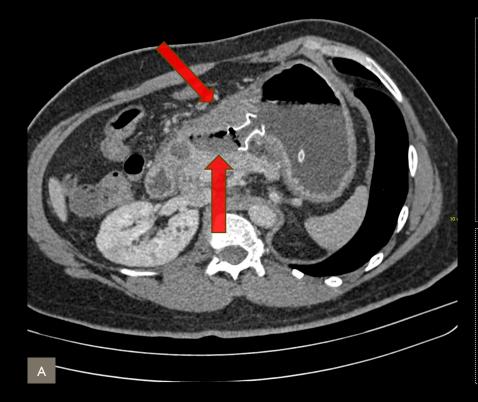
Fig. A: Computed tomography (CT) of the abdomen after the procedure, demonstrating hyperdense material located at the lesser curvature. In the region close to the lesser curvature of the stomach, a collection was observed (arrows)

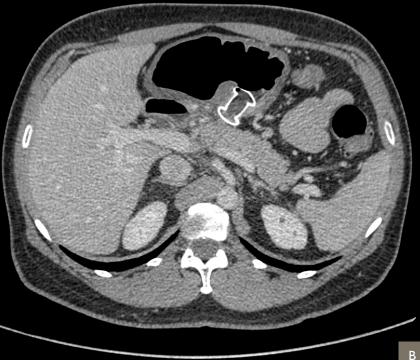
Fig. B: a new CT was performed a few days after the endoscopic procedure, which confirmed the correct positioning of the prosthesis and resolution of the collection

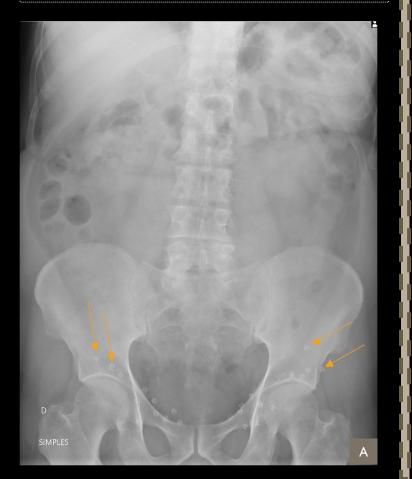
#### Hernia mesh

Fig. A: patient came to the service to undergo a contrast examination. On plain x-ray, we observed the presence of bilateral mesh for hernioplasty (arrows)

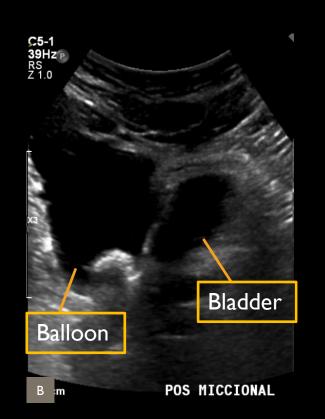
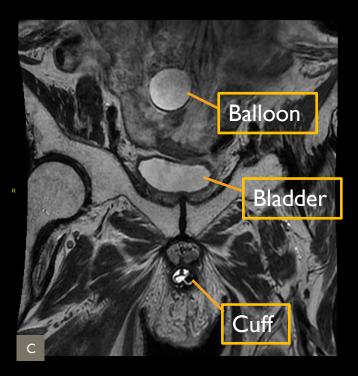
Urethral artificial sphincter

Figs. B-C abdominal ultrasound showing a hypoechoic image close to the bladder, with its own wall and that doesn't move, hyperechoic image inside. After questioning, the patient confirmed the presence of a urethral artificial sphincter

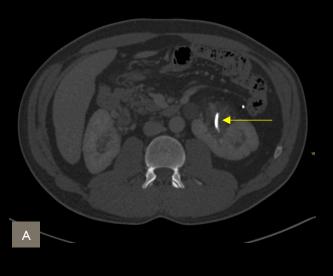
Fig. A: patient with a history of double J passage undergoes CT and as an additional finding, a remnant of the catheter is noted (arrow)

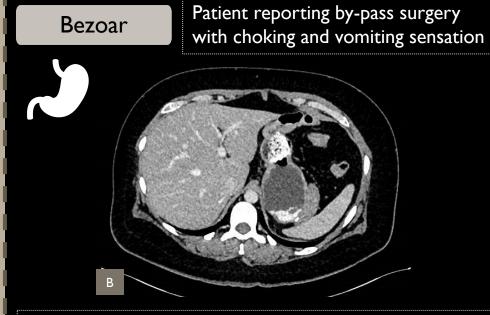
Fig. B: CT with a radiodense oval formation impacted in the gastric enteric anastomosis, associated with distension of the gastric remnant and distal esophagus upstream, suggesting an obstructive / subocclusive process (bezoar)

Fig. C: endoscopy was performed to remove the material (food remains)

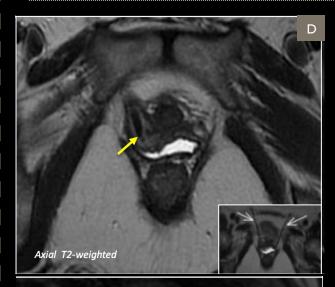
The sling that slips

Figs. D-E: MRI showing area of discontinuity and ulceration in the right lateral vagina wall (arrow), associated with inflammatory findings near the paraurethral course of the right sling stem with thickening and accentuation of the enchancement of the surroundings (circle). Indicative of erosion / extrusion of implanted surgical material (retropubic sling)

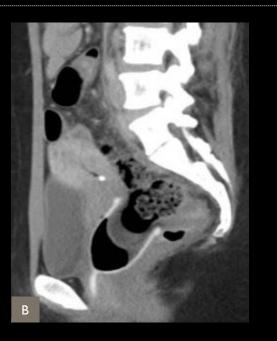
Figs.A-C: CT with presence of an inadequate positioning of a menstrual cup, with its opening directed towards the posterior wall of the vagina. Associated, there is a moderate diffuse pyelocaliceal dilation on the right (arrows), with an apparent distal ureteral path trapped inside the menstrual cup. 43-year-old female with painless abdominal distention for past 5 years, after 2 months of an emergency C-section

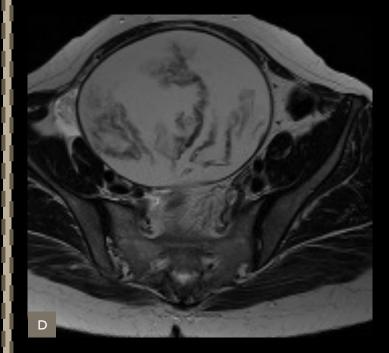
Figs. D-E: MRI images that shows voluminous cystic pelvic formation containing serping-like material floating, suggesting the possibility of a foreign body/surgical material. Surgery description: capsule opening with suggestive material of compression inside the cyst (E)
